**HERRON AVENUE SITE  
GRID EXCAVATION SUMMARY**

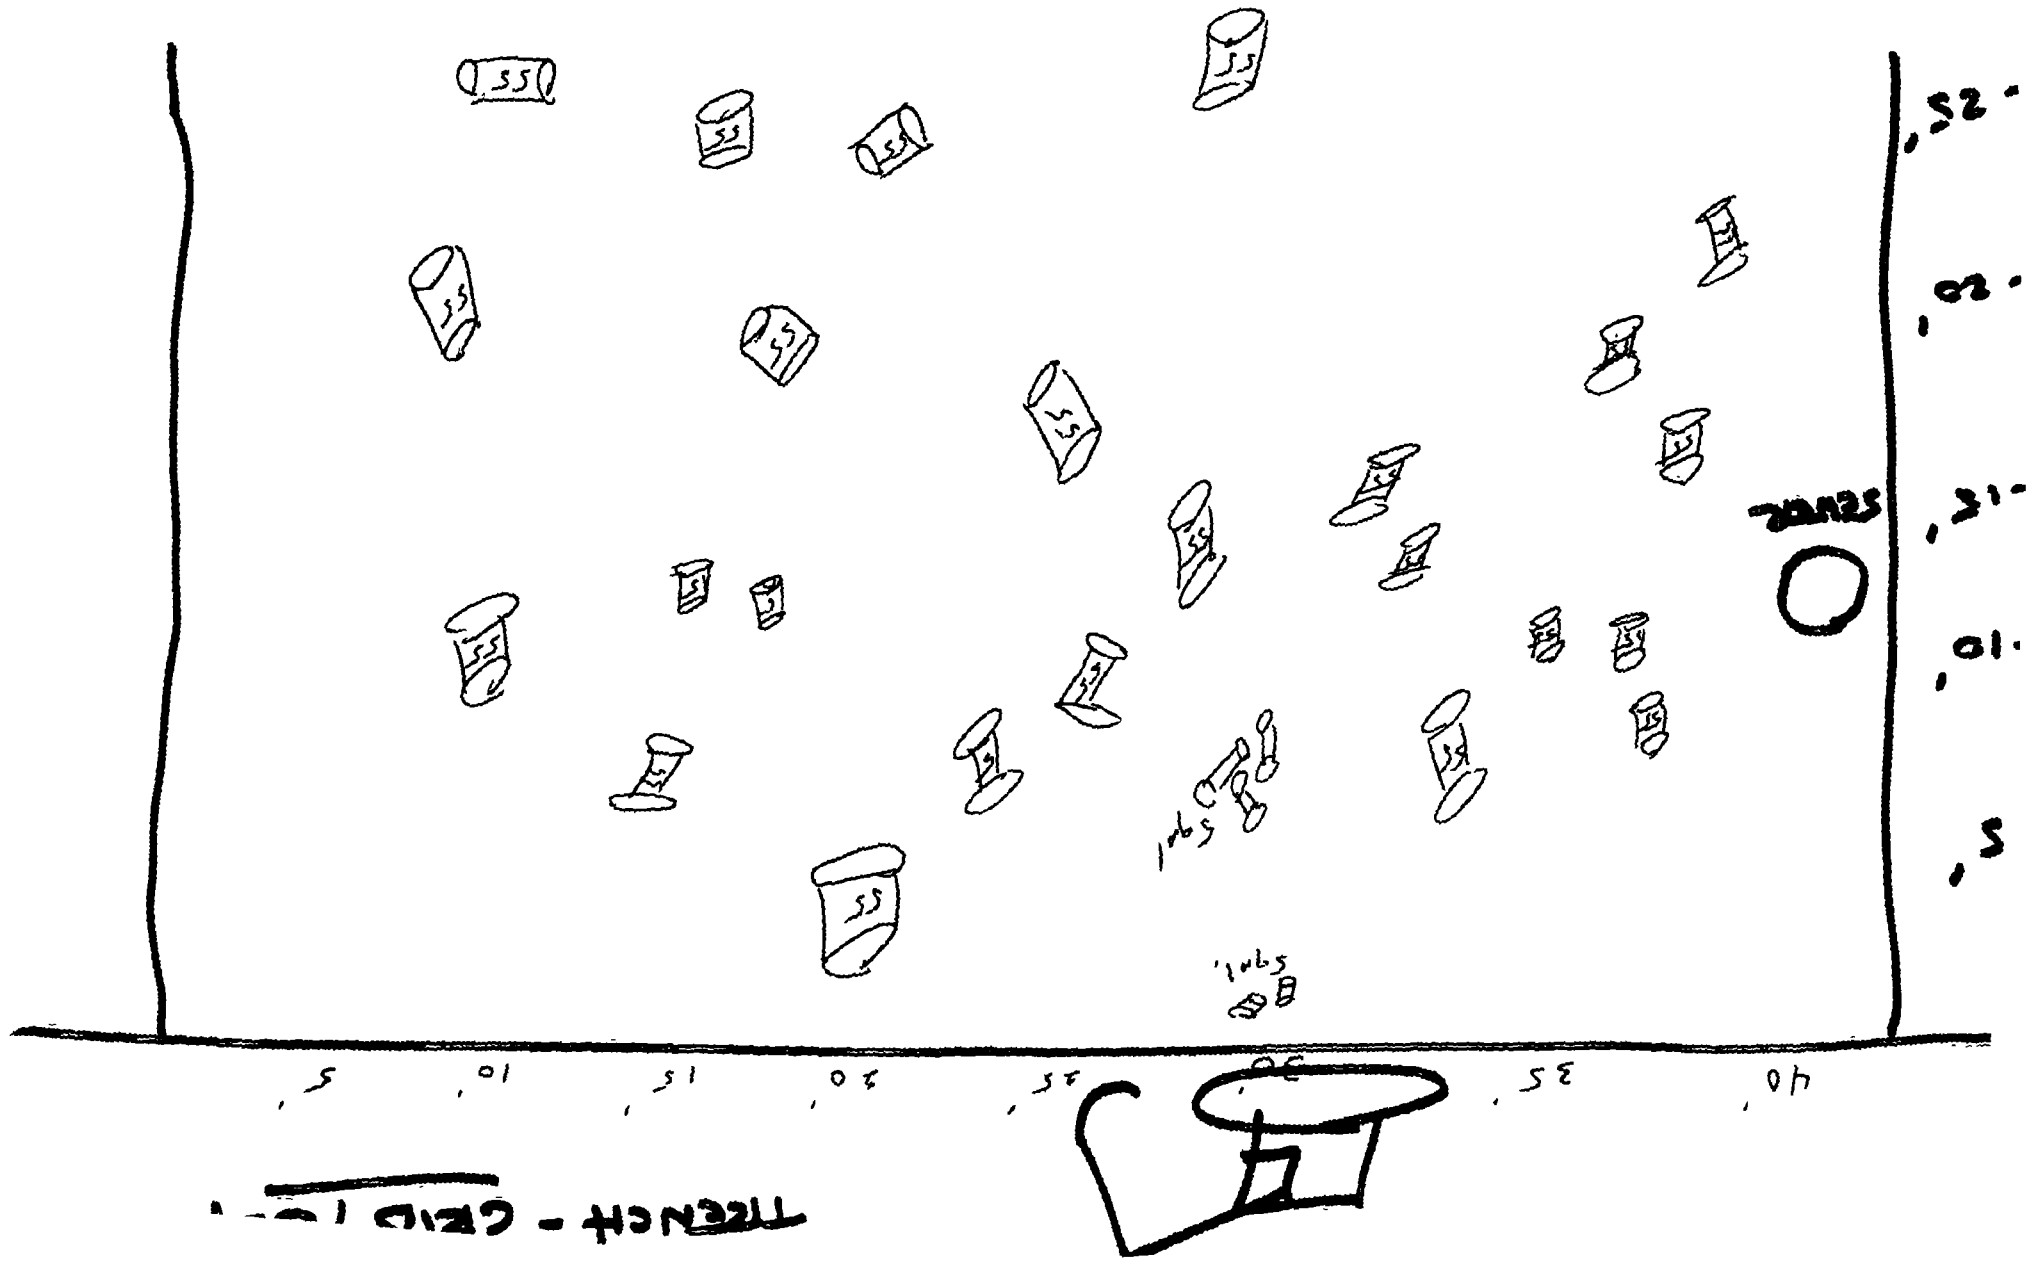
TRENCH - GRID 1

NORTH WALL OBSERVATION: From 2' - 16' - 22'  
 SOUTH WALL OBSERVATION: From 4' - 16' - 22'

Sewer pipe at 15' - 17'
